LUSCOMBE AIRPLANE CORPORATION  
P.O. Box 2128, Dallas 1, Texas

May 12, 1948

TO: All Silvaire Owners & Operators  
FROM: Service Department, Luscombe Airplane Corp.  
SUBJECT: Inspection of 18432 Rudder Horn  
SERIAL NOS. AFFECTED: 1934-5724

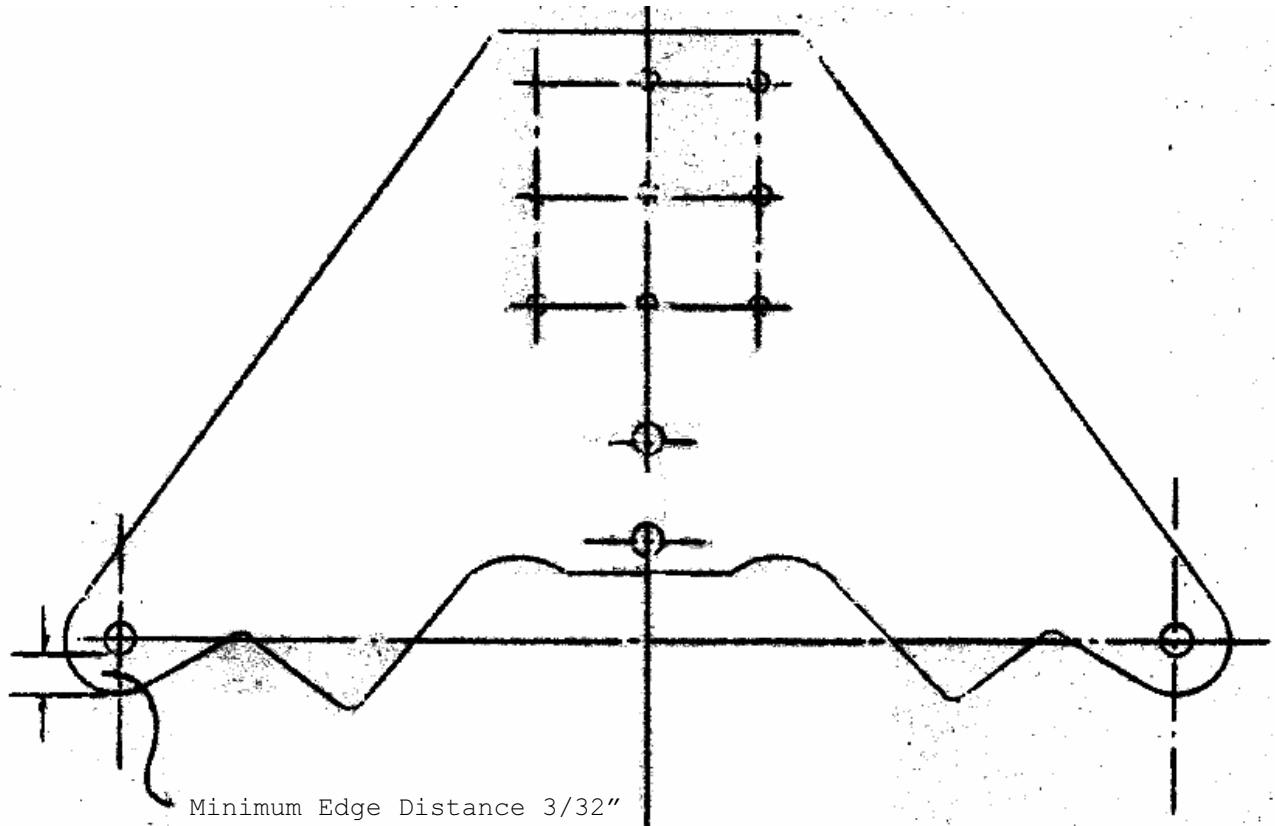
SERVICE LTR. 5-12-48

Several cases of excessive wear and elongation of eyebolt attachment holes in the rudder horn have been reported to the factory.

In all cases the subject aircraft have from 500-600 total hours operation at time of discovery of this condition.

All aircraft should be checked at each one hundred hour inspection for excessive wear at this point, minimum allowable edge distance being 3/32". (See attached sketch)

Marginal cases discovered upon inspection may be corrected by adding two rudder arm extensions, part number SK4149. These parts may be procured through the Service Department.
